# Air Solution Company

## - Case Study -

### Cottonwood Filter Screens Relieve Snow Build-up In Louvered Air Chamber

## University Biomedical Building

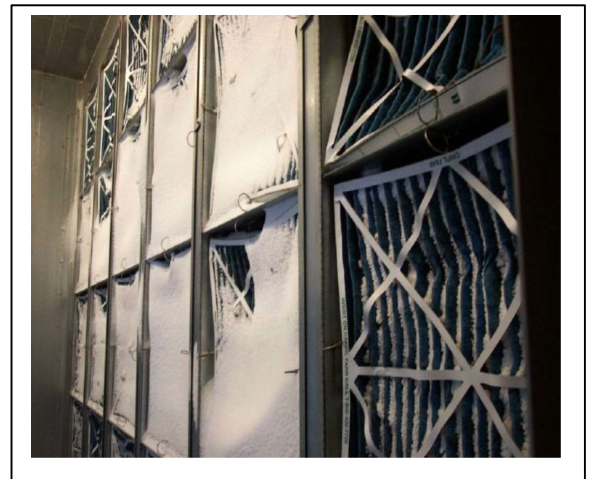
Snow shown building-up and damaging pre-filters

One of the facilities main air handling units had been experiencing on-going problems during the winter; snow would be drawn through the intake louver on one side of the building where it would accumulate on the MERV 8 pre-filters until the weight and moisture from the snow caused them to collapse; thus exposing the expensive MERV 15 bag filters which they relied upon to provide fine filtration to help in delivering optimal indoor air quality.

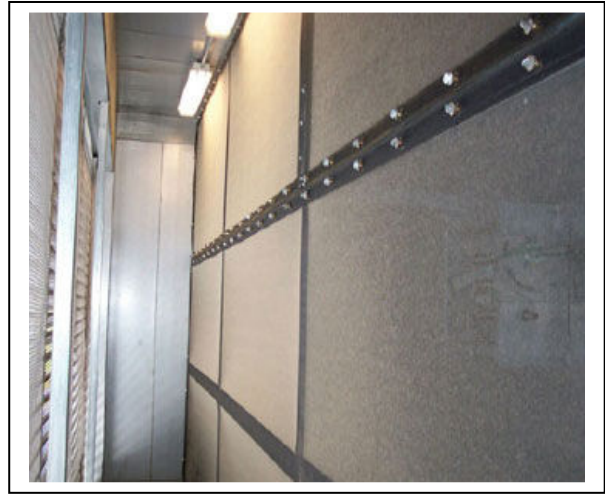
**Air Intake Filters  
Stopping Cottonwood Seed from Reaching Pre-Filters**

Since putting the filters in, they not only eliminated snow related damage, but they realized another benefit – The Air Intake Filters stopped cottonwood seed and other matter from pre-maturely fouling out the pre-filters during the spring, summer and fall. “It wasn’t until we saw the cottonwood seed building up on the Air Intake Filter Screens that we realized just how serious our cottonwood seed problem was. The cottonwood seed and other fibrous matter in the air was increasing our maintenance cost and significantly reducing the efficiency and service life of our filters” said the facility maintenance engineer.

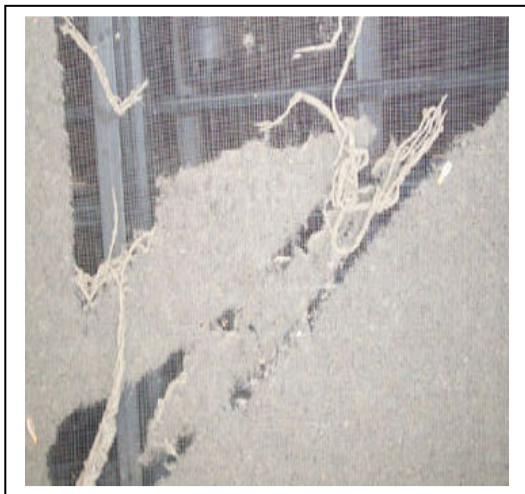
**Cottonwood Seed & Other Debris  
Simply rolls off of Air Intake Filters**

The Bio-Medical building is located near the banks of a nearby river and the campus is surrounded by densely wooded areas – and where there’s water, there’s usually a lot of Poplar Trees (also known as the cottonwood tree) and other vegetation which contribute to the bio-mass in the air during the spring, summer and fall. They had become so accustomed to frequent filter changes that until they became acquainted with the Cottonwood Filter Screens, they didn’t realize that they could get more out of their pre-filters and bag filters by protecting them from heavy face loading – The best part of using the air intake filter screens is that they dramatically reduced filter changes and reduced maintenance to about 10 minutes per cleaning using a broom versus up to 4 hours to change and dispose of the filters.
